# **INDOOR AIR QUALITY ASSESSMENT**

**John J. Shaughnessy Elementary School  
1158 Gorham Street  
Lowell, MA 01852**

Prepared by:  
Massachusetts Department of Public Health  
Center for Environmental Health  
Emergency Response/Indoor Air Quality Program  
August 2005

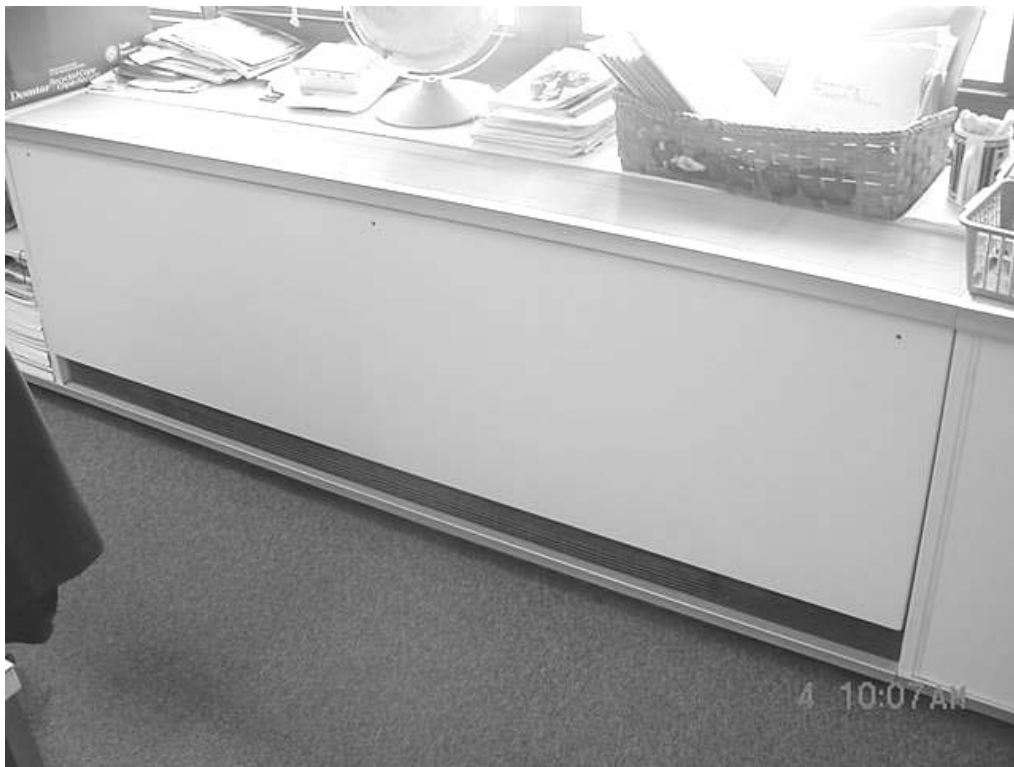
**Picture 1**

It can be seen from Table 1 that carbon dioxide levels were above 800 parts per million (ppm) in twenty-one of forty-one areas, indicating inadequate air exchange in approximately one half of the areas surveyed. Fresh air in each classroom is mechanically supplied by a unit ventilator (univent) system (Picture 1). A univent draws air from outdoors through a fresh air intake located on an exterior wall of the building and returns air through an air intake located at the base of the unit. Fresh and return air are mixed, filtered, heated and provided to classrooms through an air diffuser located on the top of the unit ([Figure 1](#)).

**Classroom Univent**

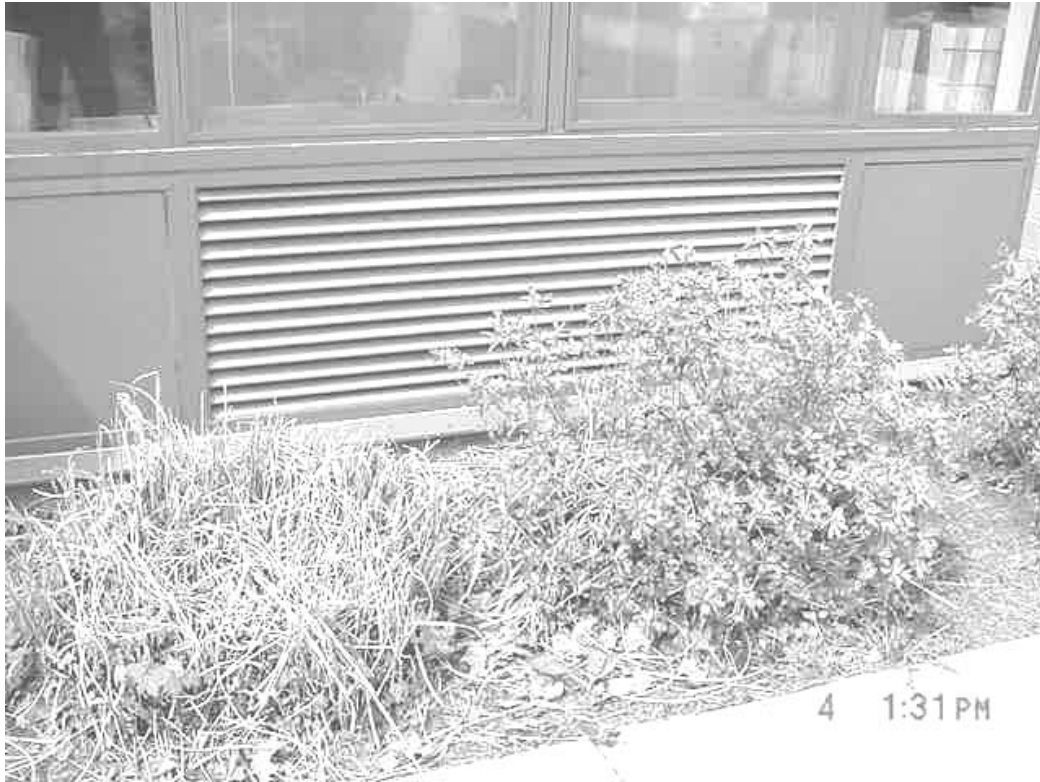
**Picture 2**

**Univent Fresh Air Intake**

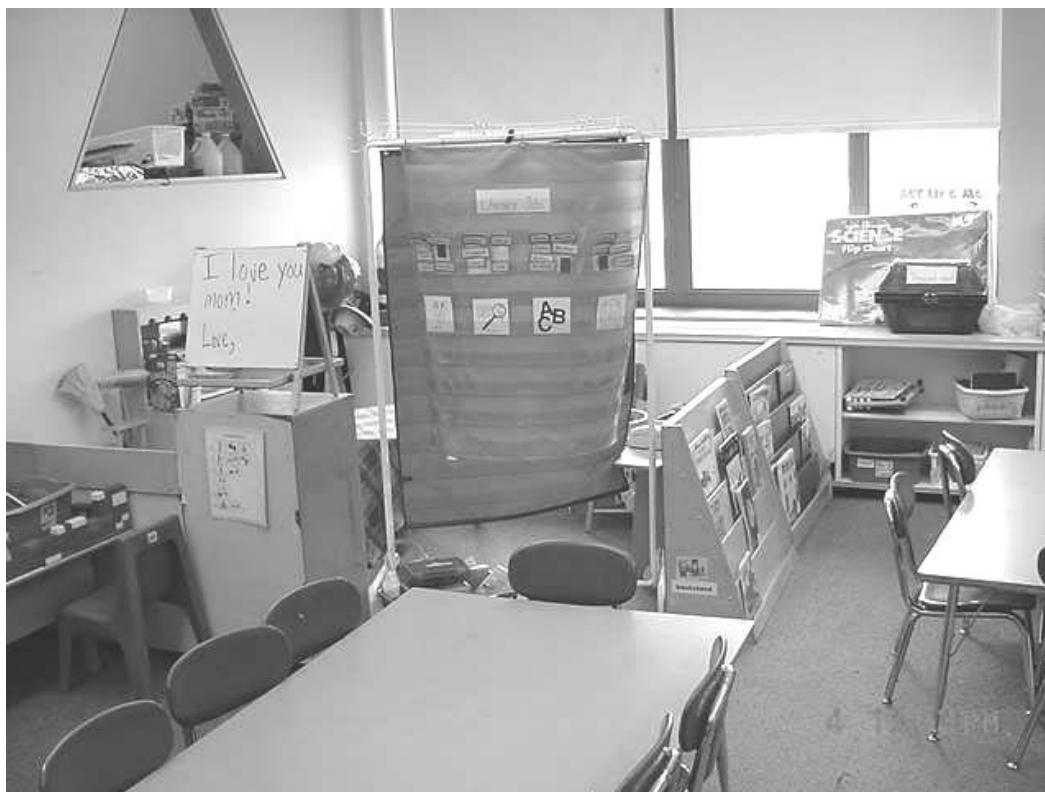
**Picture 3**

Several univents were found deactivated at the time of the assessment. The univents in classrooms A-118, A-124 and B-123 were reactivated by the school custodian; the univent in classroom A-125 had reportedly been deactivated due to chronic overheating. Obstructions to airflow, such as items on top of univents and tables and desks in front of univent returns were also observed in a few classrooms (Picture 3). To function as designed, univents must remain free of obstructions and allowed to operate.

**Classroom Items around Univent Impeding Airflow**

4. Continue to examine the exhaust system in A 203 for proper function and air exchange. Make repairs/adjustments as needed.
5. Remove all blockages from univents and exhaust vents to ensure adequate airflow.

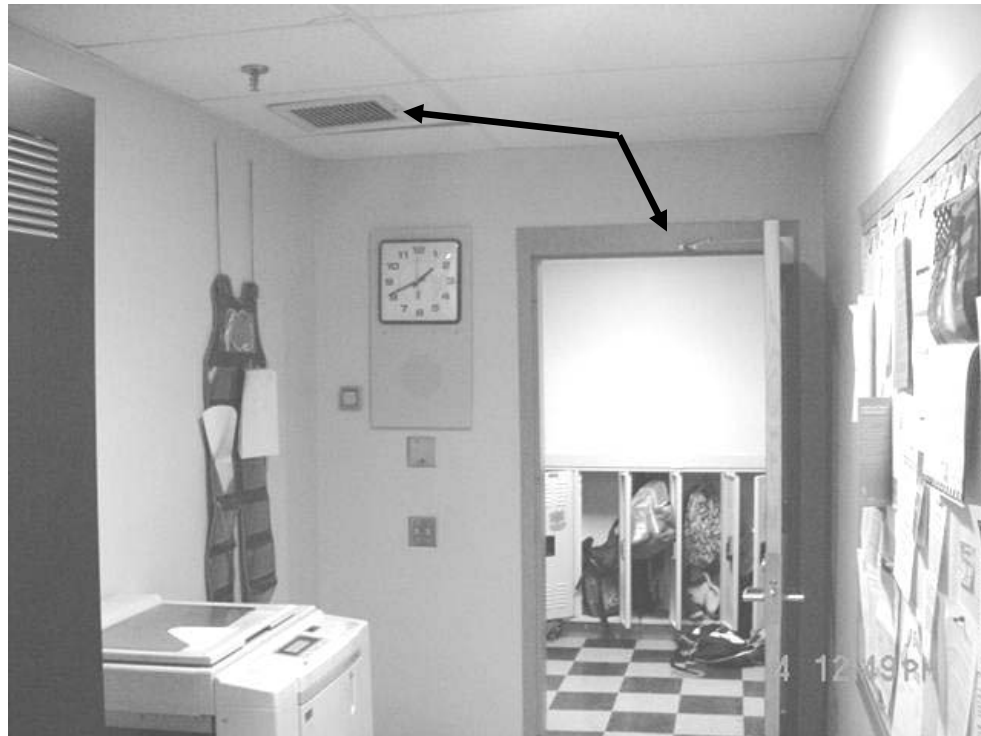
**Picture 4**

**Ceiling-Mounted Exhaust Vent and Proximity to Hallway Door**

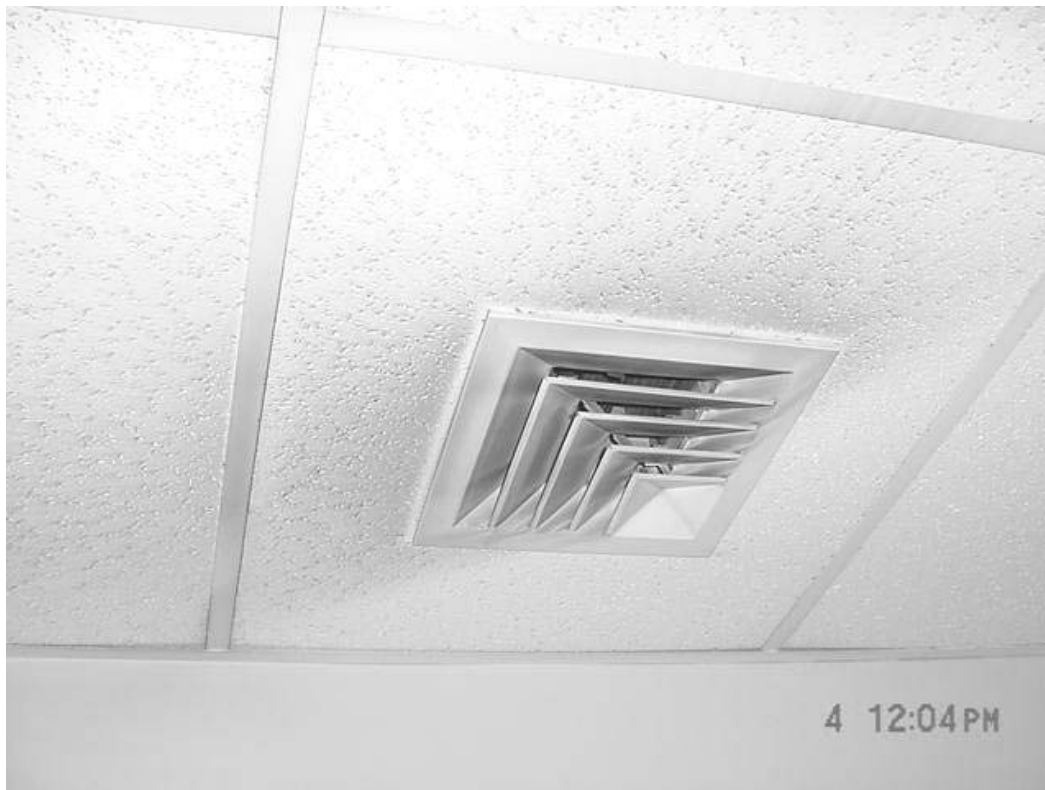
**Picture 5**

Several other conditions that can affect indoor air quality were noted during the assessment. Accumulated dust was observed on supply and exhaust vents in the kitchen area (Picture 5). Vents should be cleaned periodically to prevent aerosolization of accumulated dust. At the time of the assessment, MDPH staff recommended cleaning/changing stained tiles around these vents and monitoring for further staining. Several reasons may exist for this dust/dirt accumulation on tiles in this area. Occupants reported that the filters for the

**Ceiling-Mounted Supply Vent, Note Dark Staining on Ceiling Tile around Vent**

15. Clean/change stained ceiling tiles in kitchen and surrounding areas and monitor for further staining.
16. Clean exhaust/return vents periodically to prevent excessive dust build-up.

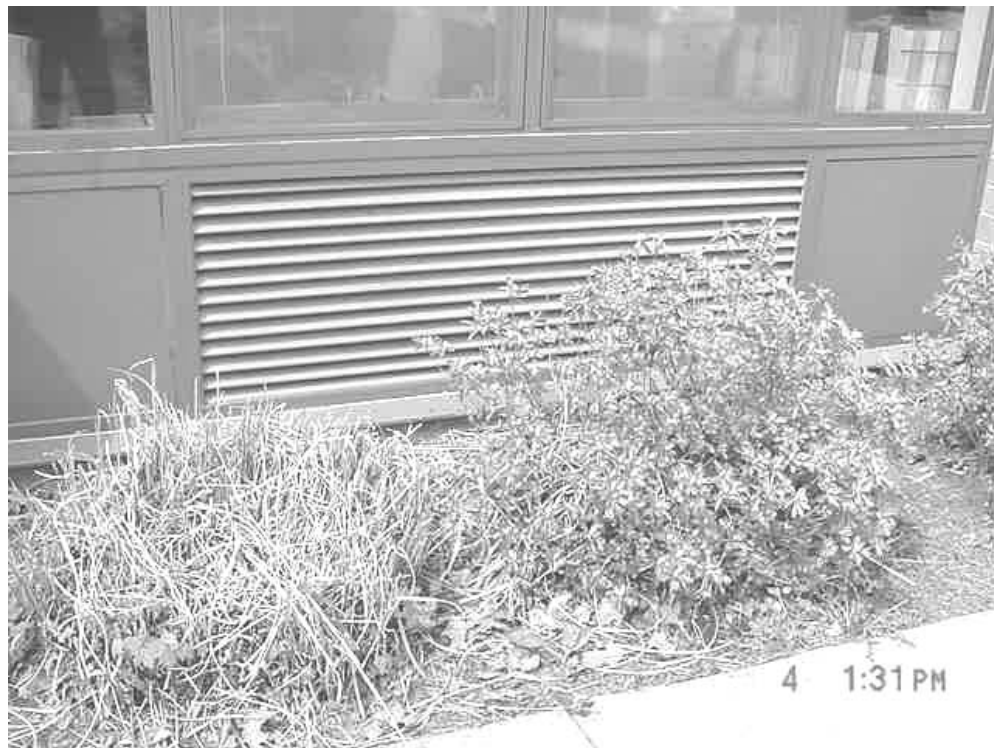
**Picture 6**

Bushes/shrubbery were observed in close proximity to univent air intakes along the perimeter of the building (Picture 6). Plant growth in close proximity to univent air intakes can draw in allergens such as mold and pollen.

**Bushes/Shrubbery in Close Proximity to Univent Air Intakes**

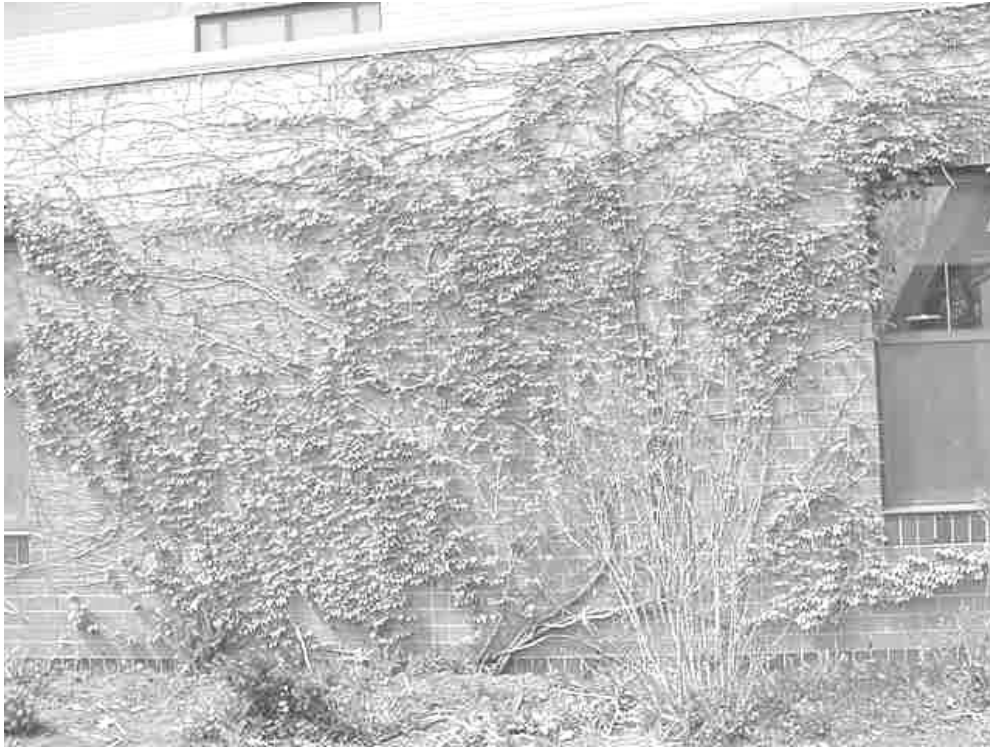
**Picture 7**

Clinging plants were observed on exterior brickwork (Picture 7). Clinging plants can cause water damage to brickwork by inserting tendrils into brick and mortar. Water can penetrate into the brick along the tendrils, which can subsequently freeze and thaw during the winter. This freezing/thawing action can weaken bricks and mortar, resulting in wall damage.

**Clinging Plants on Exterior Wall**

11. Remove plants growing against building and its foundation to prevent water intrusion through brickwork.

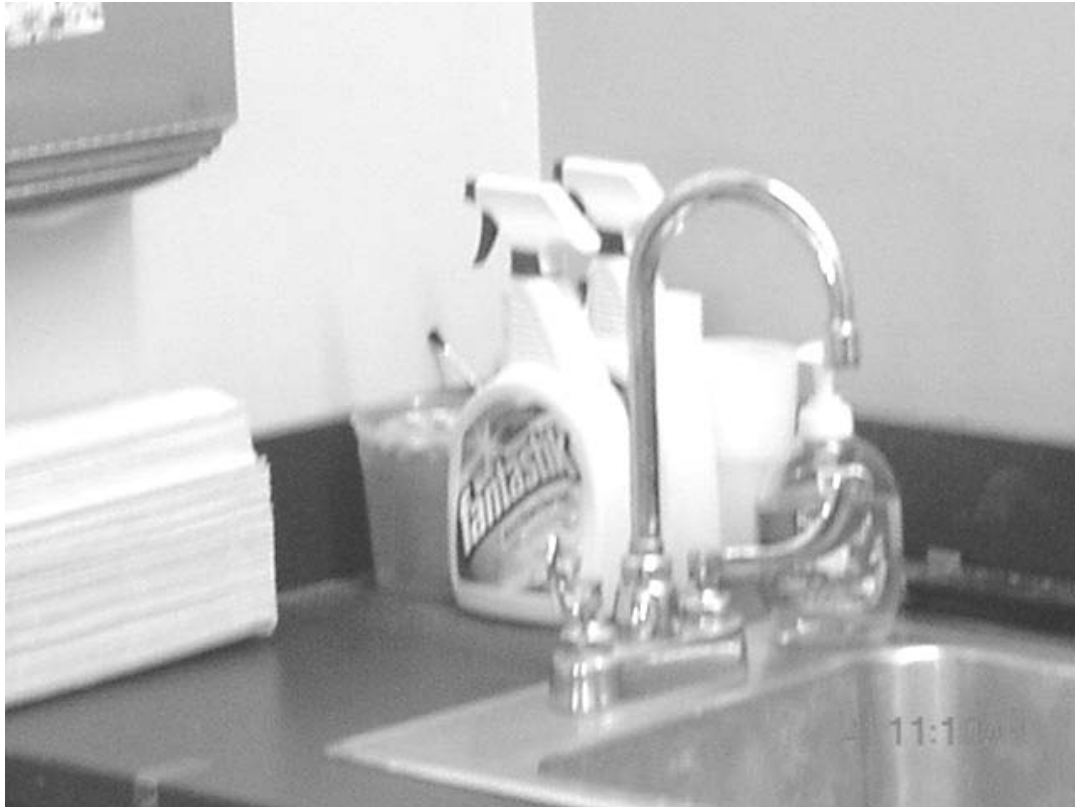
**Picture 8**

Cleaning products were found on countertops and in unlocked cabinets beneath sinks in some classrooms (Picture 8). Like dry erase materials, cleaning products contain VOCs and other chemicals that can be irritating to the eyes, nose and throat of sensitive individuals. Also of concern are unlabelled bottles and containers. Products should be kept in their original containers and be clearly labeled for identification purposes, especially in the event of an emergency.

**Spray Cleaning Bottles on Sink Countertop**

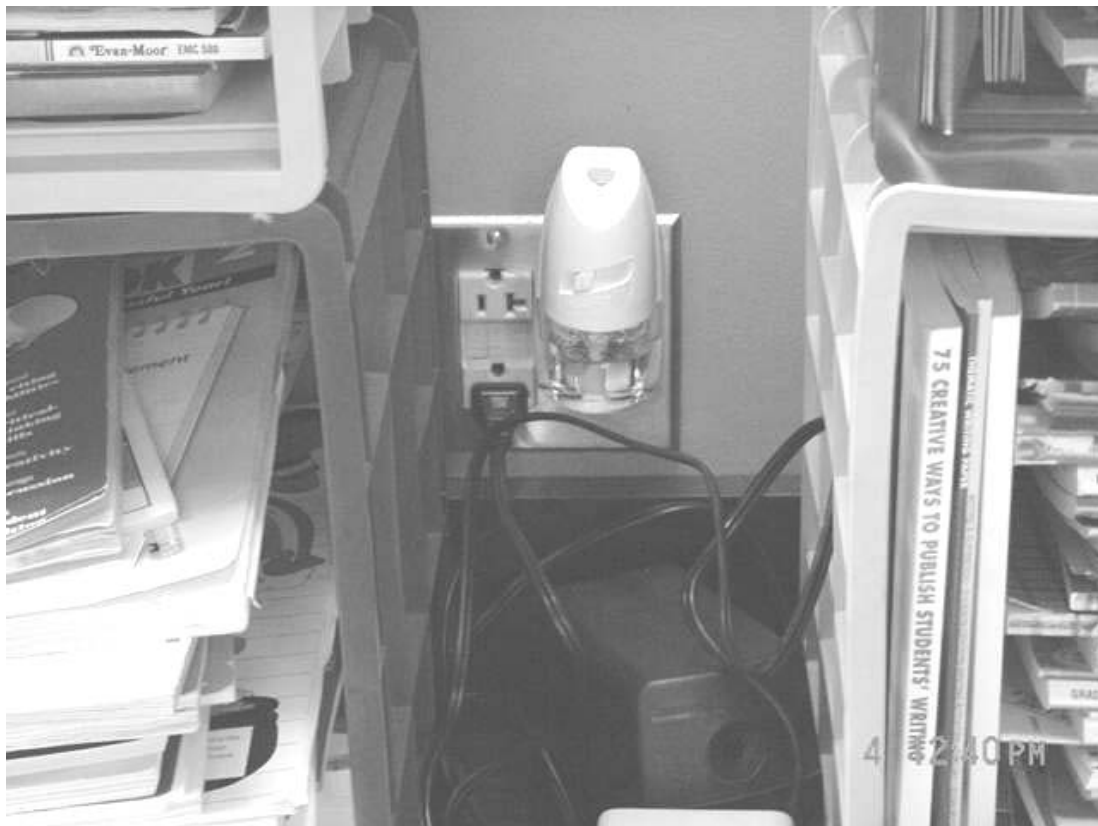
**Picture 9**

A strong fragrance was detected in classroom A-116. The source was a plug-in air freshener (Picture 9). Air fresheners contain chemicals that can be irritating to the eyes, nose

and throat of sensitive individuals. Furthermore, air fresheners do not remove materials causing odors, but rather mask odors that may be present in the area.

**Plug-In Air Freshener in Classroom**

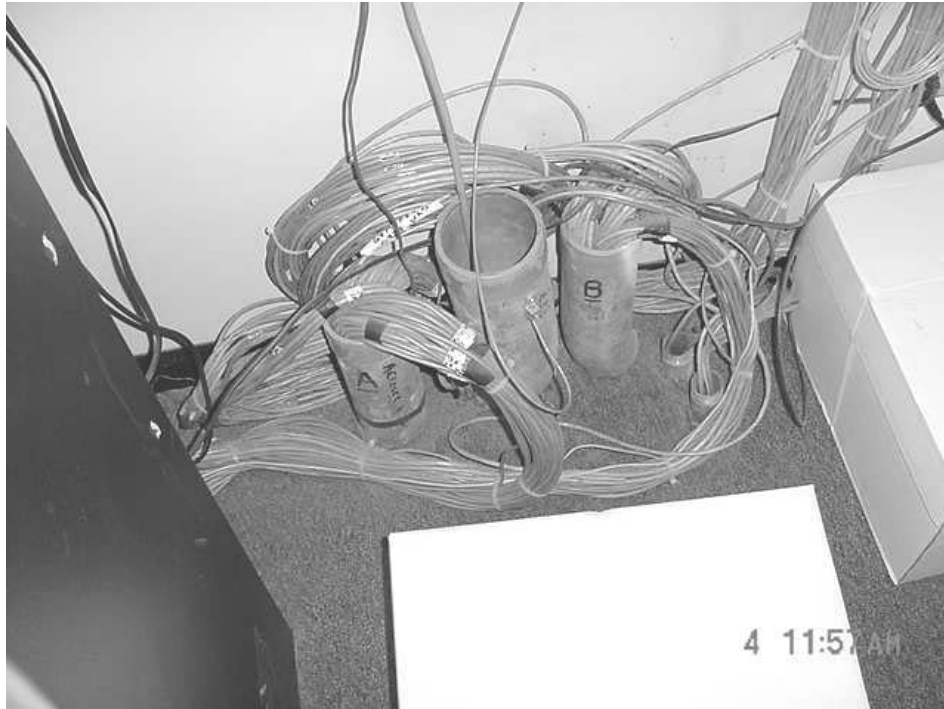
**Picture 10**

Periodic odors originating from open utility holes in the floor of the main office (Picture 10) were reported by occupants. Open utility holes in walls and/or floors can provide a means of egress for odors, fumes, dusts and vapors between rooms and floors. Although no odors were detected the day of the assessment, MDPH staff recommended that these utility holes be sealed.

**Open Utility Pipes in Main Office**

12. Seal breaches around pipes and other spaces between rooms and floors (e.g., the main office) to prevent movement of crawlspace odors and particles.

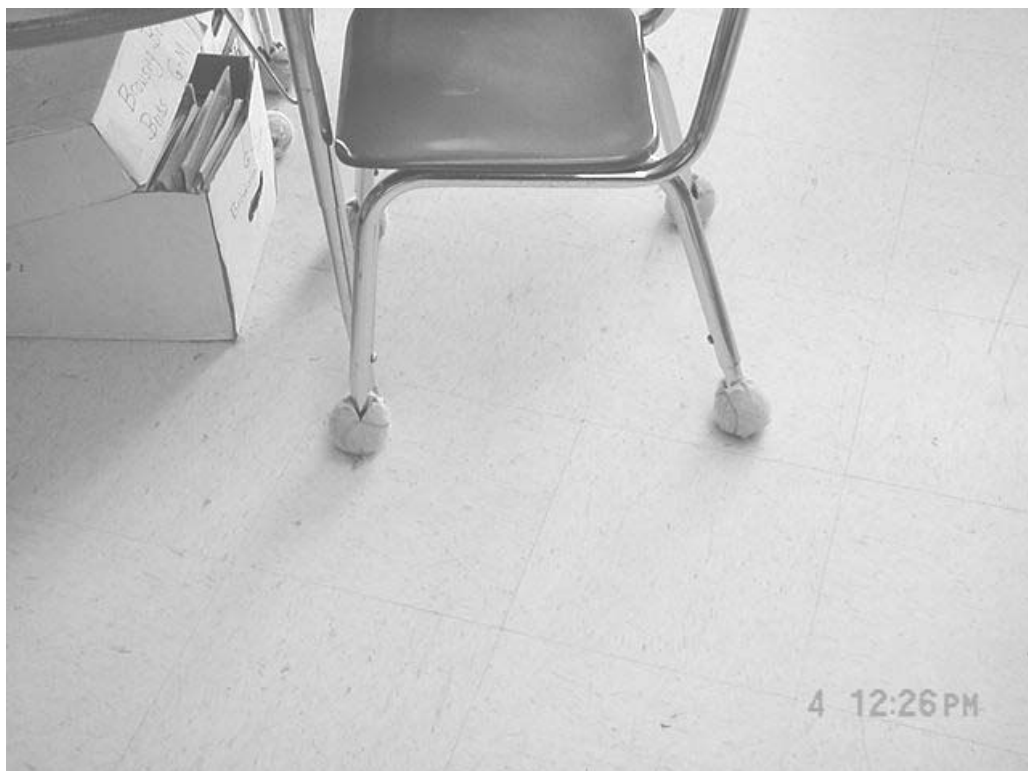
**Picture 11**

In an effort to reduce noise from sliding chairs, tennis balls had been sliced open and placed on chair legs (Picture 11). Tennis balls are made of a number of materials that are a source of respiratory irritants. Constant wearing of tennis balls can produce fibers and off-gas VOCs. Tennis balls are made with a natural rubber latex bladder, which becomes abraded when used as a chair leg pad. Use of tennis balls in this manner may introduce latex dust into the school environment. Some individuals are highly allergic to latex (e.g., spina bifida patients) (SBAA, 2001). It is recommended that the use of materials containing latex be limited in buildings to reduce the likelihood of symptoms in sensitive individuals (NIOSH, 1997). A question and answer sheet concerning latex allergy is attached as [Appendix B](#) (NIOSH, 1998).

**Tennis Balls on Chair Legs**

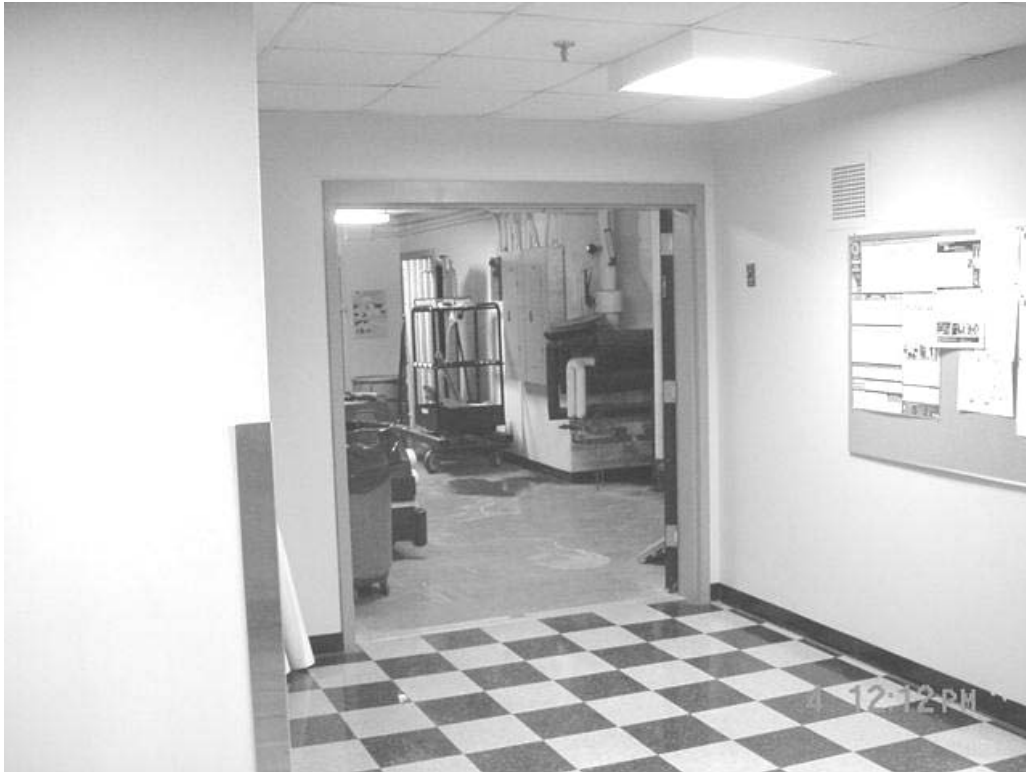
**Picture 12**

rooftop AHU that services this area had not been changed frequently, but was recently changed. Without cleaning/changing filters regularly the activation of the AHU can re-aerosolize dirt, dust and particulates, which can collect on ceiling tiles as a result of impaction from air movement from the vent. Secondly, MDPH staff observed that the boiler room doors were pegged open (Picture 12) and a sign was posted to leave doors open. With doors left open, fuel/boiler room odors and particulates from combustion (e.g., soot) can migrate into the hallway between the boiler room and the cafeteria.

**Open Boiler Room Doors near Cafeteria**

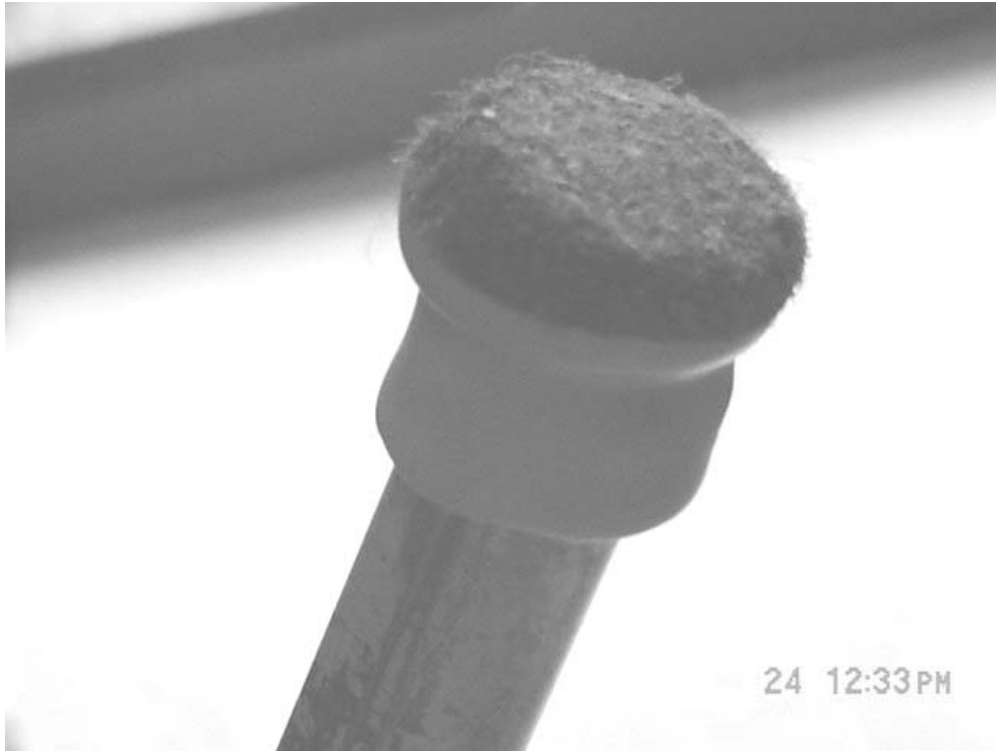
**Picture 13**

**“Glides” for Chair Legs that can be used as an Alternative to Tennis Balls**
